PROFESSIONAL HOME INSPECTIONS LLC

RESIDENTIAL PROPERTY INSPECTION

1234 Main Street
FALL BRANCH, TN 37656

09/05/2022 9:00AM

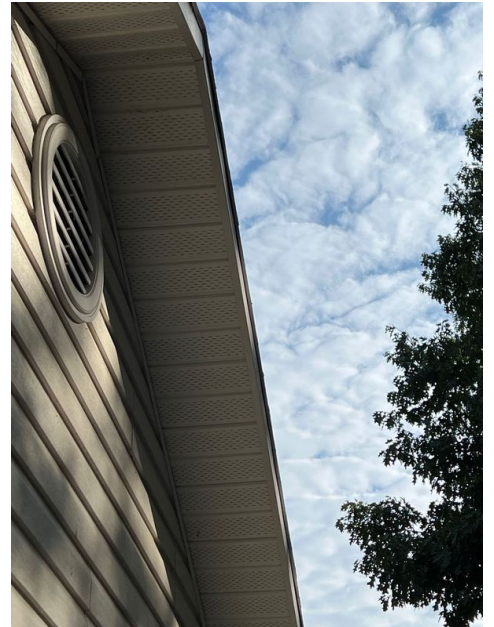
4.4.3 Shingles

INSTALLATION - INADEQUATE OVERHANG

Contact a qualified roofing professional.

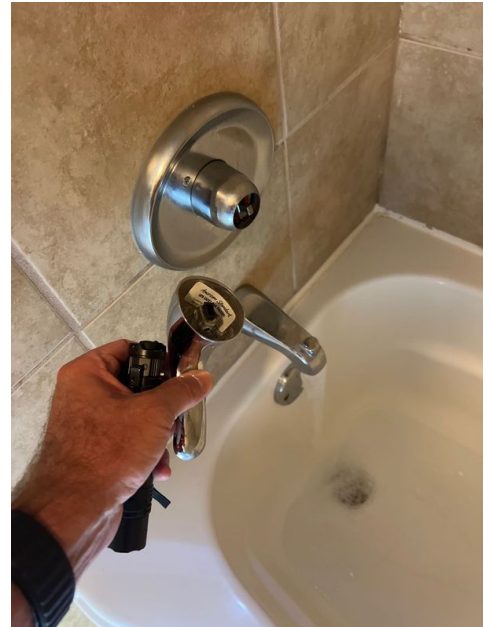
7.6.2 Bathtub(s)

FAUCET/VALVES - HANDLE LOOSE

Marginal Defect

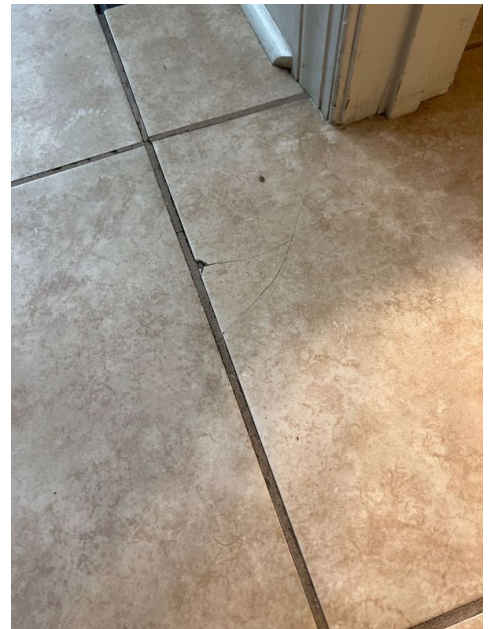
8.8.1 Floor Condition

TILE FLOORING - DAMAGED

Contact a qualified tile contractor

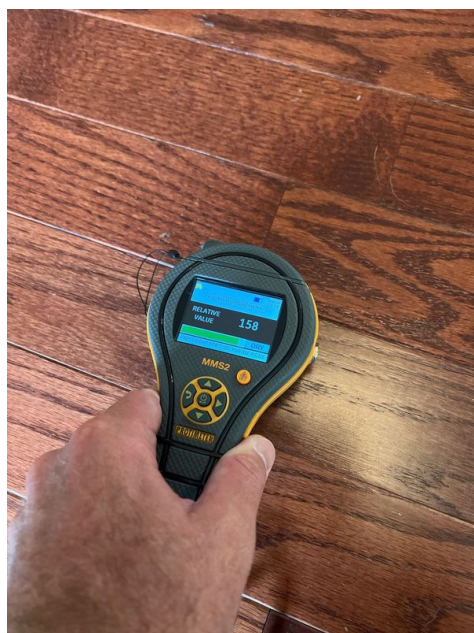
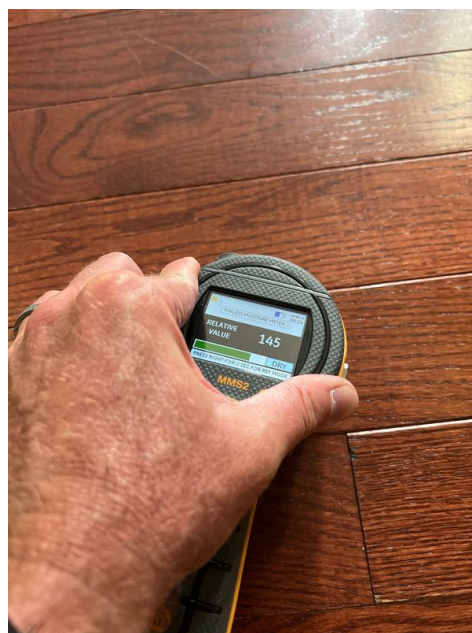
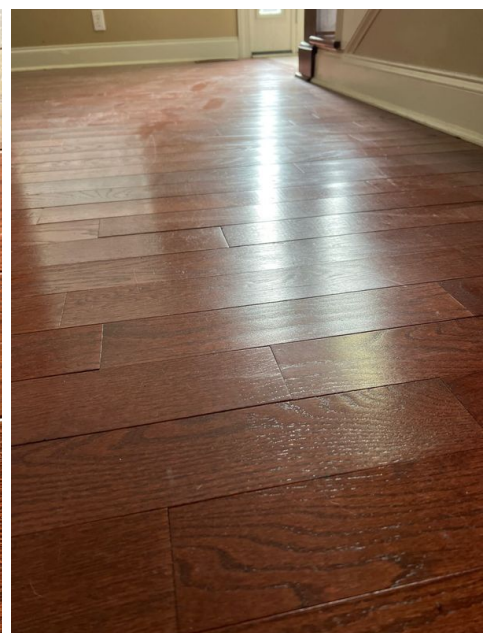
8.8.2 Floor Condition

HARDWOOD - CUPPED (ELEVATED MOISTURE CONTENT)

Contact a qualified professional.

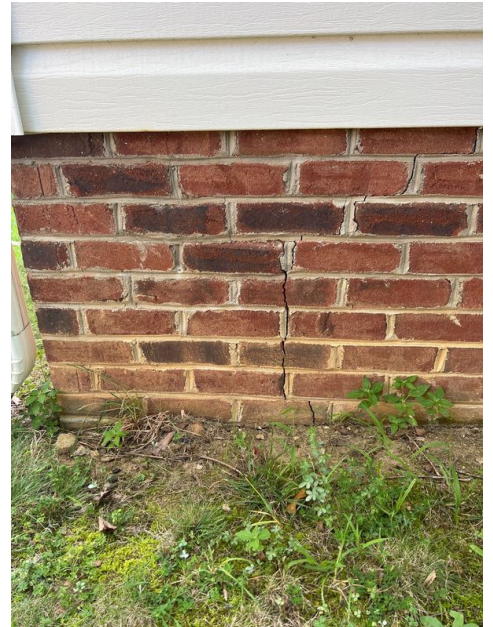
18.5.2 Foundation Walls - CSM

CRACKING - OUTSIDE OF NORMAL TOLERANCES

Significant Defect

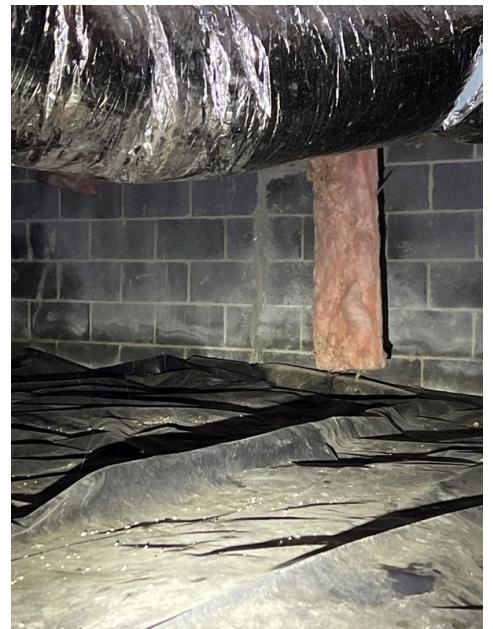
18.5.3 Foundation Walls - CSM

CRACKING - PATCHED/COVERED

Marginal Defect
