PROFESSIONAL HOME INSPECTIONS LLC

RESIDENTIAL PROPERTY INSPECTION

1234 Main Street
FALL BRANCH, TN 37656

09/05/2022 9:00AM

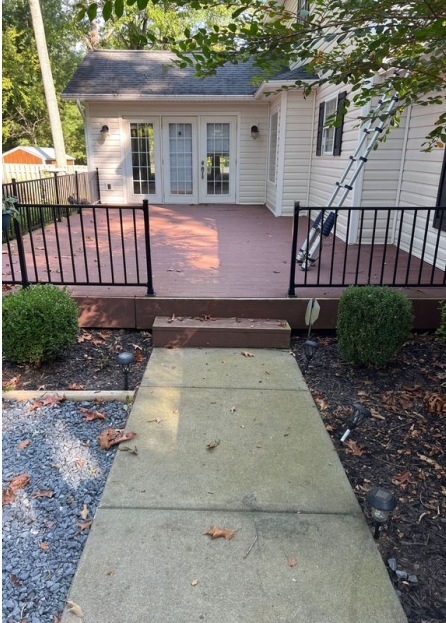
Decks: Structural Assembly - Not Visible (Clearance)

LMT - The structural assembly for the referenced deck was not visible due to the deck's proximity to the ground. The condition of this deck is excluded from this inspection.

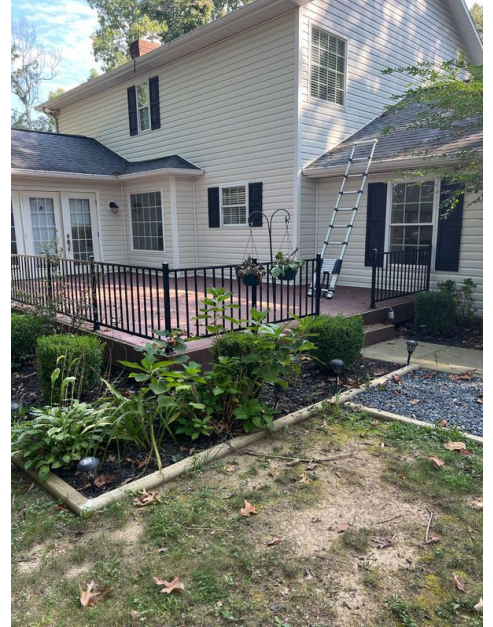
- ⚠ 3.3.1 Grounds - Grading/Lot Drainage: Grading - Not Designed to Manage Rainwater
 - ⊖ 3.5.1 Grounds - Decks: Deck(s) - Sagging
 - ⊖ 3.8.1 Grounds - Guardrails, Stair Rails, & Handrails: Guardrail - Height Less Than 36"

Recommendation

Contact a qualified grading contractor.

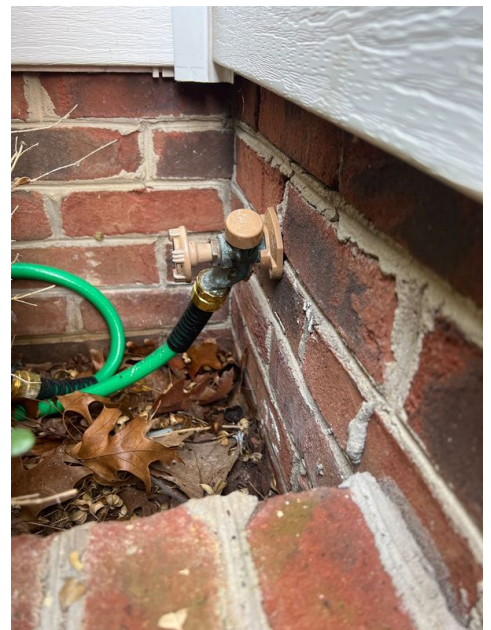
3.10.1 Exterior Spigots

- ⊖ 3.8.2 Grounds - Guardrails, Stair Rails, & Handrails: Stair Railing - Spacing Exceeded
 - 🔧 3.10.1 Grounds - Exterior Spigots: Spigot(s) - Loose at Wall

Recommendation

Contact a qualified professional.

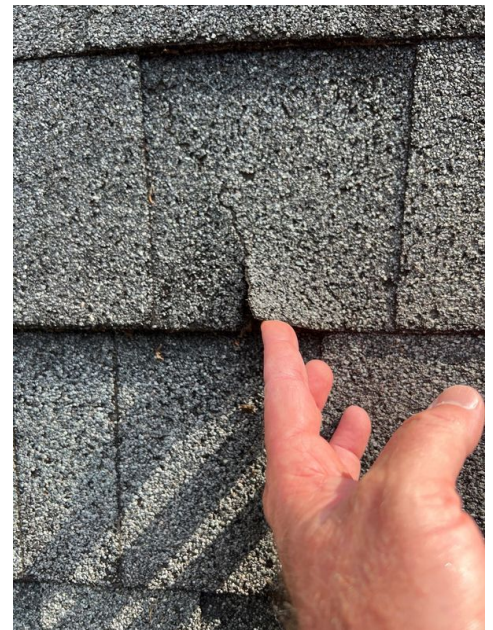
- ⊖ 4.4.1 Roof - Shingles: Damage - Areas of Minor to Moderate Damage
 - ⚠ 4.4.2 Roof - Shingles: Surface - Blistering
 - ⊖ 4.4.3 Roof - Shingles: Installation - Inadequate Overhang

Recommendation

Contact a qualified roofing professional.

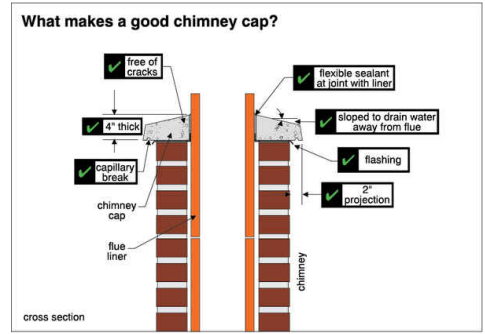
4.7.1 Chimney

Marginal Defect

Recommendation

Contact a qualified masonry professional.

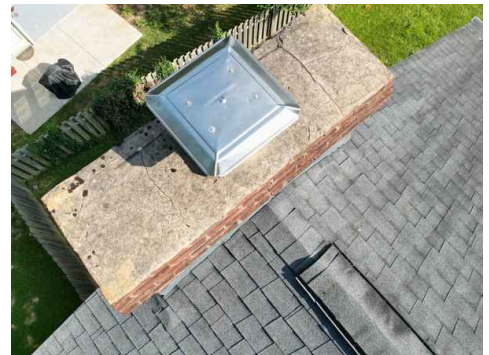
4.7.2 Chimney

Marginal Defect

Recommendation

Contact a qualified chimney contractor.

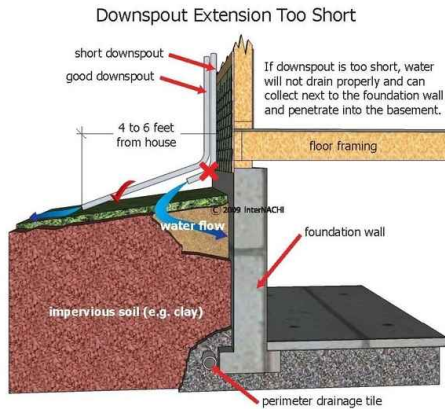
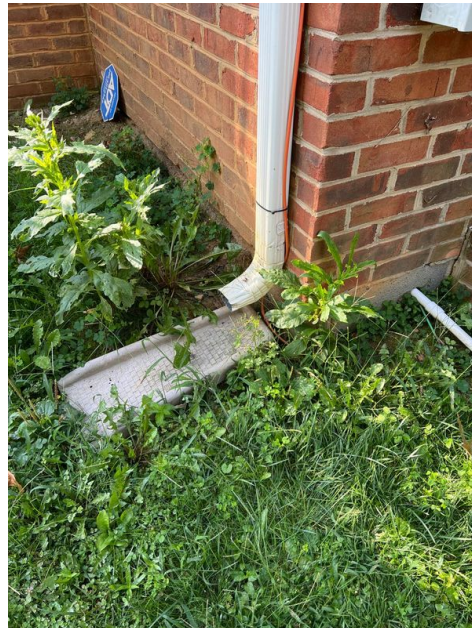
4.8.1 Gutters/Downspouts

Marginal Defect

Recommendation

Contact a qualified gutter contractor

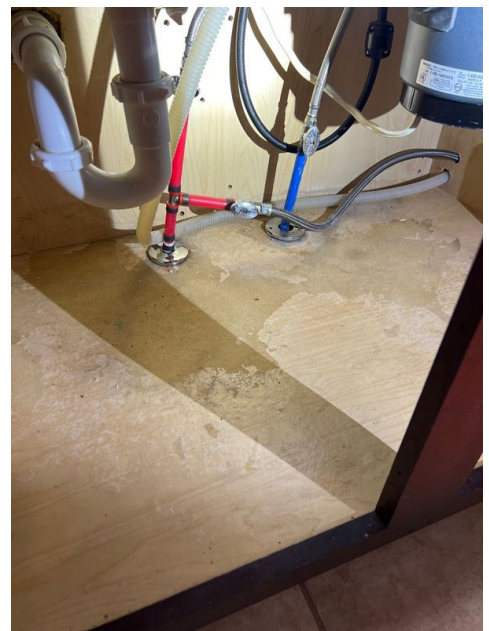
MOISTURE DAMAGE - MINOR TO MODERATE

Minor to moderate moisture damage was present on the cabinet floor below the sink. Repairs are recommended to be conducted to any damage present as needed by a qualified person.

Recommendation

Contact a qualified handyman.

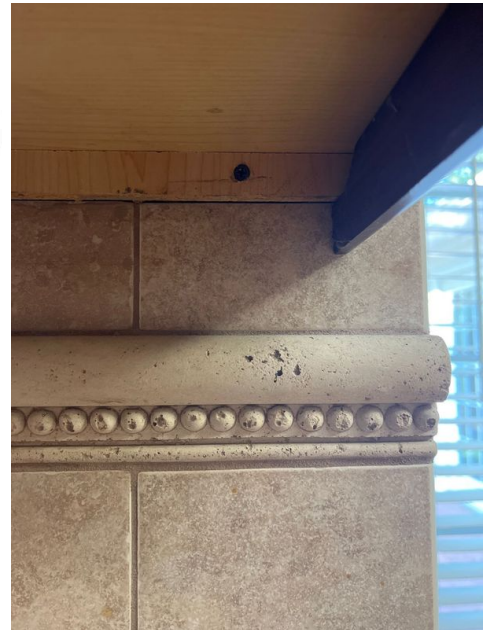
8.2.2 Cabinets, Countertops

CABINETRY - IMPROPER FASTENERS

Improper fasteners were used to secure the wall cabinetry instead of the manufacturer supplied or recommended pan head screws. Improper fasteners may not have the shear strength that the manufacturer supplied pan head screws would, and could allow for failure. Replacement of the fasteners is recommended to be conducted by a cabinet installation contractor.

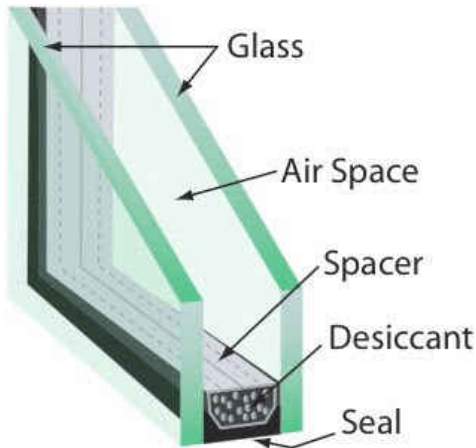
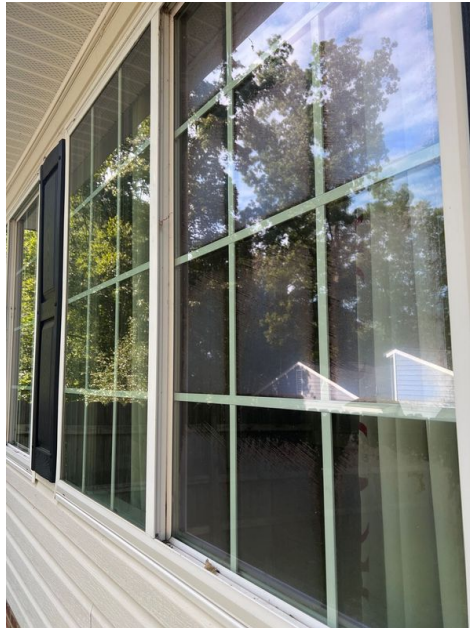
8.3.1 Windows

Marginal Defect**GLASS - SEAL FAILURE**

There was window glass with seal failure present. This is where the double pane glass loses its adhesion with the inner spacer, allowing moisture and/or debris in between the panes of glass. Seal failure can result in loss of energy efficiency and can obscure the visibility through the glass. Some windows may not show signs of seal failure due to desiccant in the glass spacer absorbing moisture in between the panes. Weather conditions in the future (high humidity, etc.) may reveal more seals that are failed than what was observed at the time of inspection. A review of all windows in the home with replacement of any affected glass found is recommended to be performed by a window company or glazing contractor.

Recommendation

Contact a qualified window repair/installation contractor.

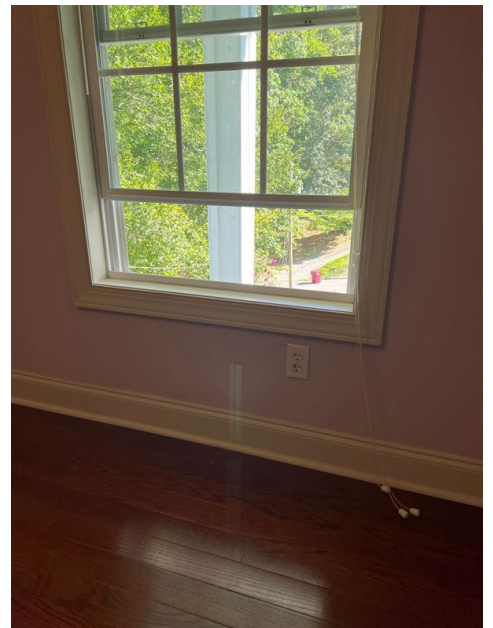
8.3.2 Windows

Marginal Defect**SAFETY - FALL PROTECTION MISSING**

SFTY - There were windows present that were within 24 inches of the floor and higher than 72 inches from finished grade outside. Fall protection is recommended to be installed on these windows for child safety by a qualified person. More info can be found at the link below.

Recommendation

Contact a qualified professional.

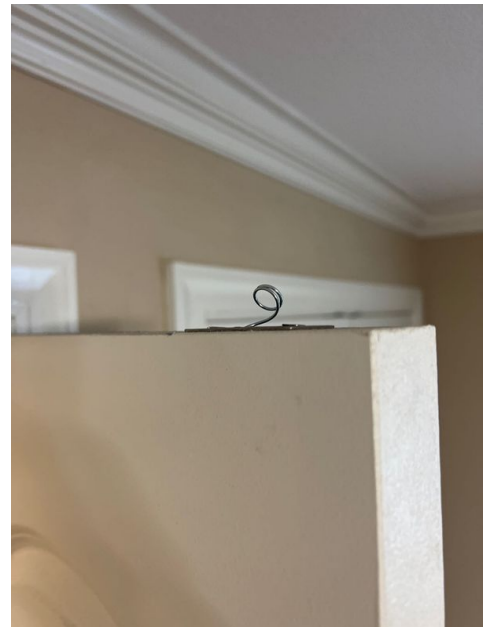
8.5.1 Interior Doors

The door was not latching properly. Adjustments or modifications as needed for proper operation is recommended to be conducted by a qualified person.

Recommendation

Contact a qualified handyman.

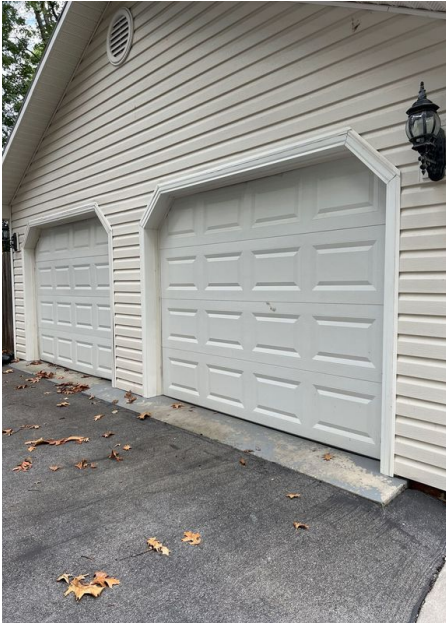
**Garage Door(s): Cosmetic Dents and Dings**

FYI - Dents and dings were present on the garage door(s) that were cosmetic in nature. This did not affect the door(s) functionality at the time of inspection.

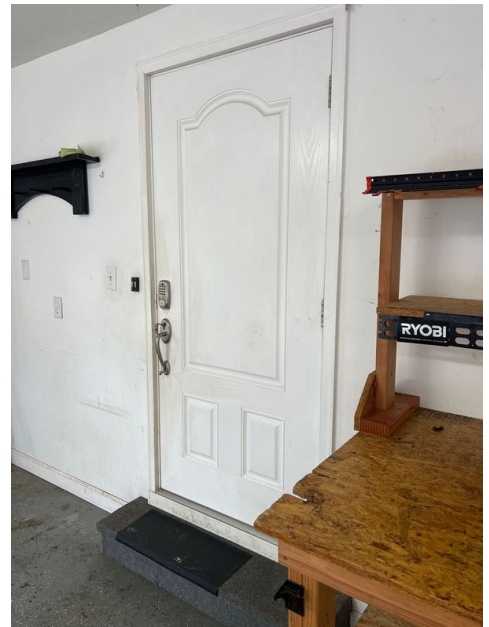
SFTY - The door between the garage and living areas did not meet today's safety standards for the separation of garage and living space. A 20 minute fire rated door, or a steel or solid wood door measuring no less than 1 3/8" thick, is recommended to be installed as a safety upgrade by a qualified professional.

Contact a qualified professional.

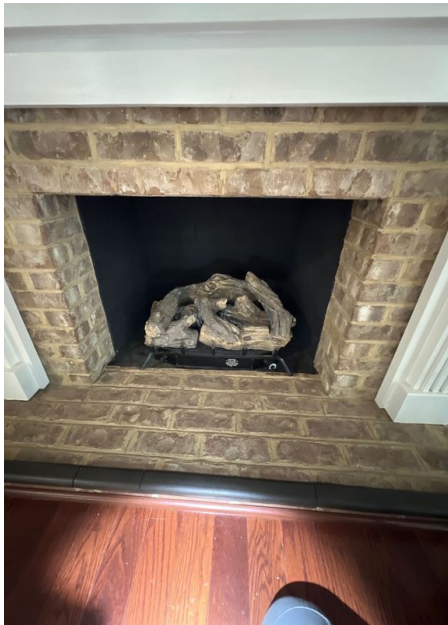
Fireplace(s): Pilot Light Not Lit

EXCL - The pilot light for the gas logs was not lit at the time of inspection. Gas fireplaces are not tested for functionality if the pilot is not lit, as there are specific igniting instructions that must be closely followed for safety, and these ignition steps vary from manufacturer to manufacturer. Gas log manufacturers highly recommend that the instruction manual is given to the new owners so that the steps for ignition are known and safety precautions are followed. I recommend confirming proper operation of the logs prior to the end of your inspection contingency period.

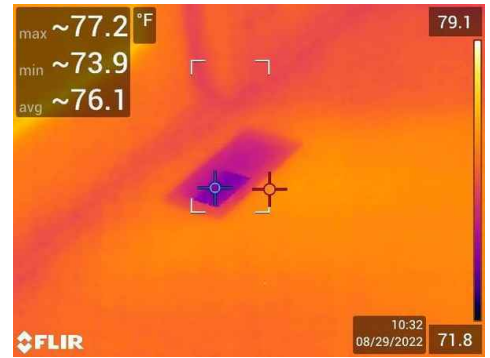
The HVAC system was not functional utilizing normal operating controls, at the time of inspection. Repairs or replacement of the unit(s) as needed for proper operation is recommended to be performed by an HVAC contractor.

Contact a qualified heating and cooling contractor

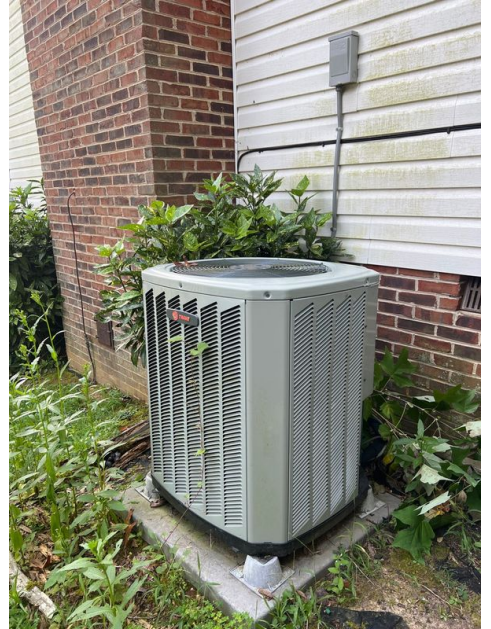
Marginal Defect
EXTERIOR UNIT - NOT LEVEL

The exterior unit was not level. This can put strain on the fan motor, prevent proper lubrication of the compressor, affect system performance, and void the system's warranty. Properly leveling the unit and/or pad is recommended to be conducted by an HVAC contractor or other qualified person.

When installing the unit on a support pad, such as a concrete slab, consider the following:

- The pad should be at least 1" larger than the unit on all sides.
- The pad must be separate from any structure.
- The pad must be level.
- The pad should be high enough above grade to allow for drainage.
- The pad location must comply with National, State, and Local codes.

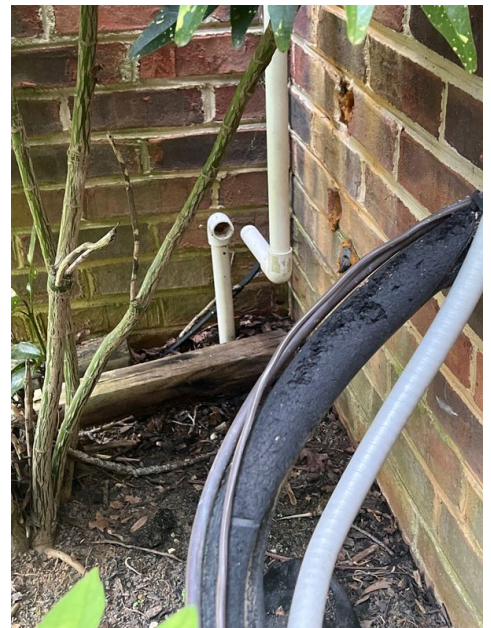
Marginal Defect**CONDENSATE DRAIN - TERMINATED NEAR FOUNDATION**

The condensate drain pipe or tubing terminated at or near the foundation of the home. This can allow water to saturate the soil in this area, possibly entering back into or under the structure. Extending the drain away from the foundation is recommended to be conducted by a qualified person.

Contact a qualified professional.

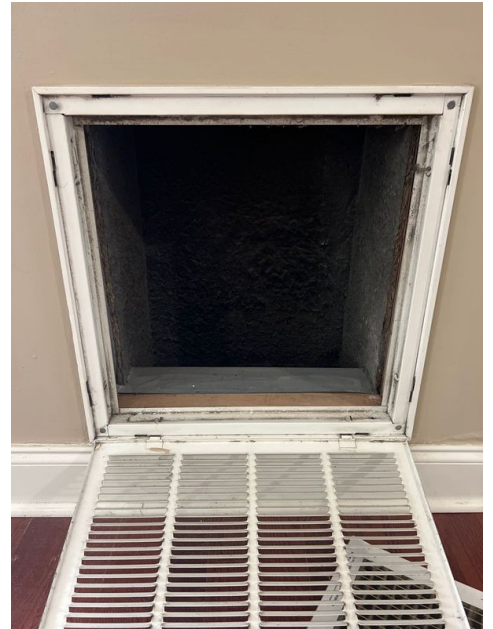
11.10.1 Air Filter/Return Plenum

Marginal Defect**FILTER(S) - MISSING**

An air filter was not installed at the time of inspection. This allows dust and debris to enter the interior HVAC unit, which could possibly damage the unit, or impair its efficiency due to large particulates reaching the evaporator. An evaluation, cleaning, and servicing of the unit is recommended to be performed by an HVAC contractor due to the missing filter.

Contact a qualified HVAC professional.

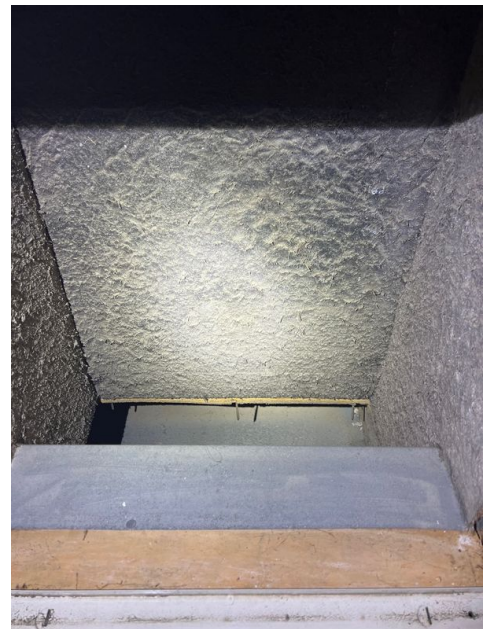
11.10.2 Air Filter/Return Plenum

Marginal Defect**RETURN PLENUM/DUCT - VISIBLE DUST PRESENT**

Dust was present at visible portions of the return plenum and/or ductwork. Individual perception and sensitivity varies greatly to an acceptable amount of dust in these areas, and this dust may be more of an issue to people with allergies or asthmatic conditions. If this dust is of concern, I recommended contacting a duct cleaning company for cleaning.

Contact a qualified professional.

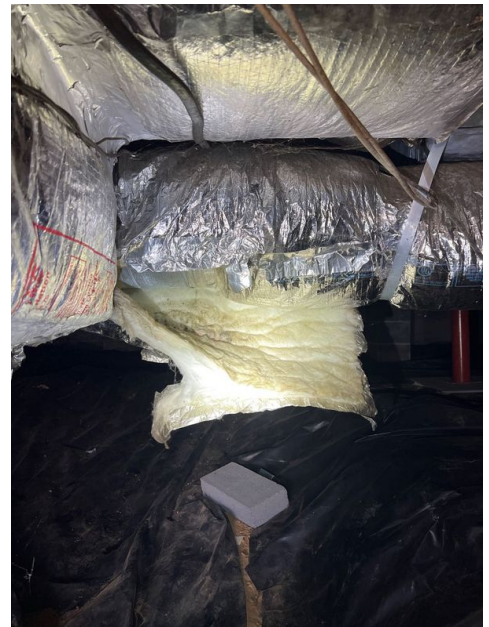
11.18.1 Visible Ductwork

DUCTWORK - MISSING/DAMAGED INSULATION

Areas of the ductwork had missing or damaged insulation present. Evaluation and repairs or replacement of any damaged portions of ductwork is recommended to be performed by an HVAC contractor.

Contact a qualified HVAC professional.

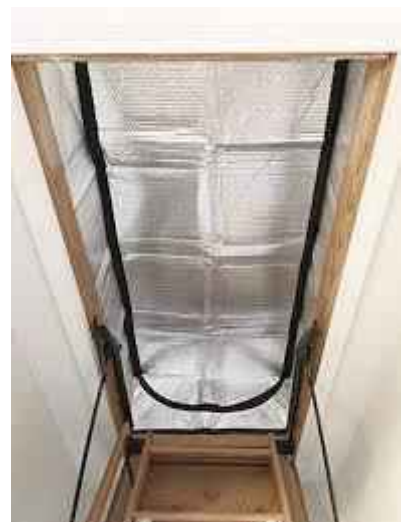
15.3.1 Attic Access

The attic opening over the pull down stairs was not insulated. This can affect the energy efficiency and "comfort" level of the home. I recommend adding an insulated cover over the access. Here's a link that discusses this further:

Contact a qualified professional.

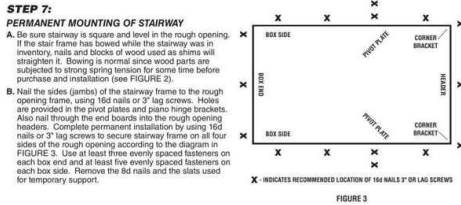
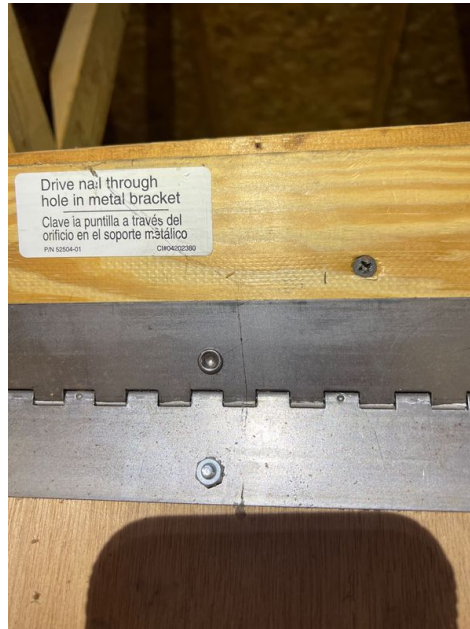
15.3.2 Attic Access

PULL DOWN STAIRS - IMPROPER FASTENERS

The pull down stairs were secured to the framing with improper fasteners. Pull down stair manufacturers highly recommend using 16d nails, as screws do not have the sheer strength to support the ladder and weight of a person. Proper securement of the stairs is recommended to be conducted by a qualified person.

Contact a qualified professional.

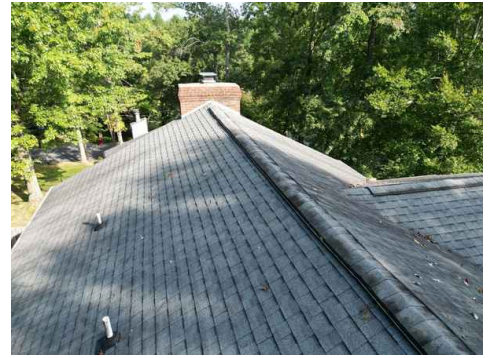
Although a ridge vent was present on top of the roof surface, a true ridge vent was not "cut in" or fully cut in, in the attic. Ridge venting assists with the overall ventilation allowing hot air to be expelled. An evaluation is recommended to be performed by a qualified contractor, with repairs made as needed to achieve proper ventilation.

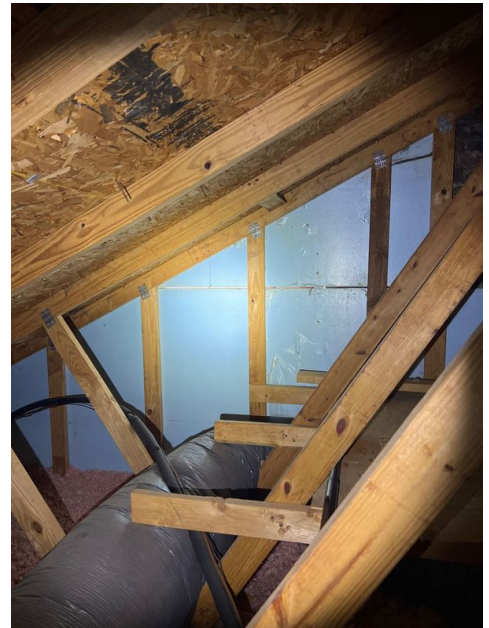
15.5.1 Roof Structure/Framing

GABLE WALL(S) - OSB NOT PRESENT OVER WALL FRAMING

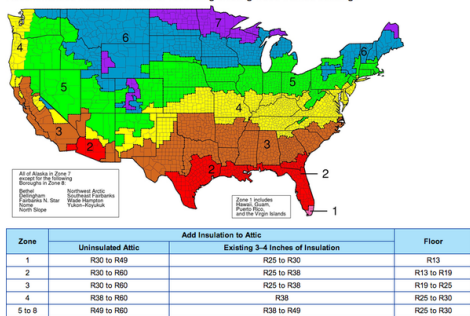
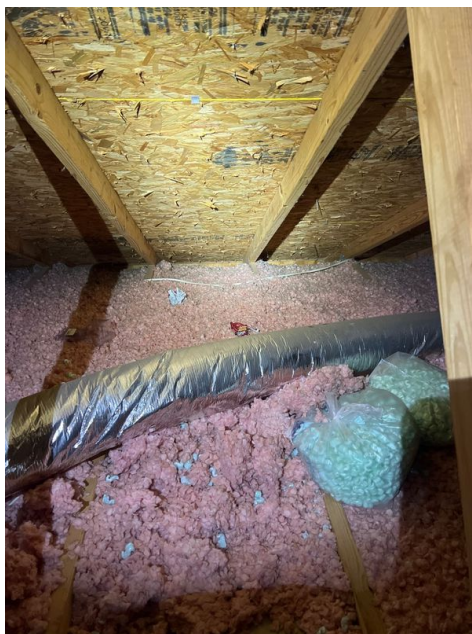
15.6.1 Insulation

INSULATION - INADEQUATE (6" OR LESS)

Six inches or less of insulation was present in areas of the attic. This affects the energy efficiency and comfort level of the home. Current energy star guidelines call for approximately 14 inches (R-38 rating). The installation of additional insulation is recommended to be conducted by an insulation contractor.

Contact a qualified insulation contractor.

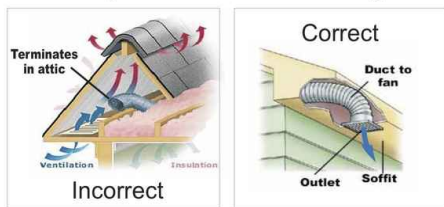
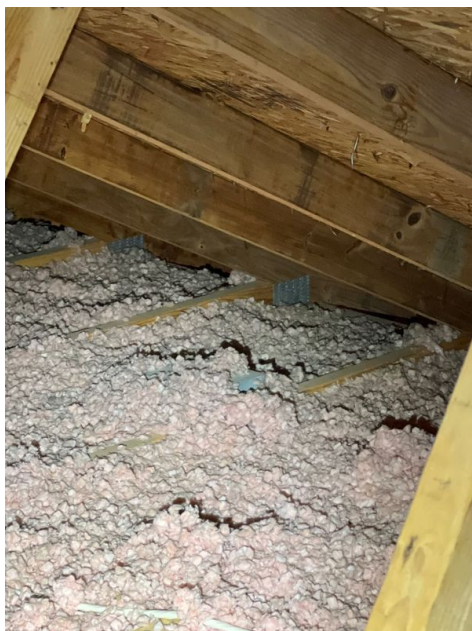
15.7.1 Exhaust Fan(s)

There were exhaust fan(s) present that were terminating in the attic. Exhaust fans should be vented to the exterior of the home to limit condensation and moisture in the attic. Repairs to properly terminate the exhaust fan(s) is recommended to be performed by a qualified professional.

Contact a qualified professional.

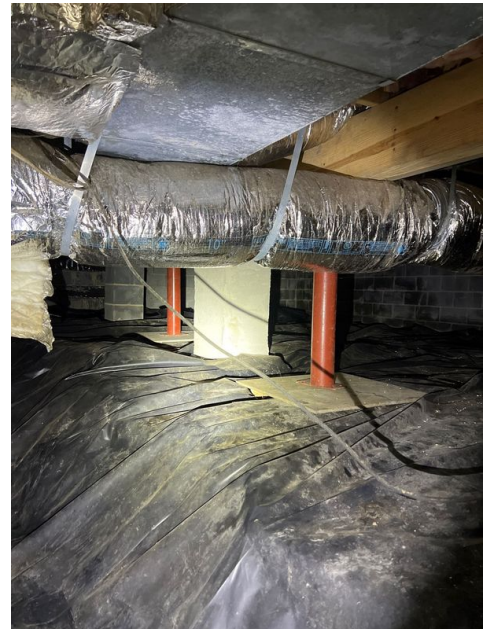
16.7.1 Floor Structure Support

UNCONVENTIONAL SUPPLEMENTAL SUPPORT ADDED

Contact a qualified professional.

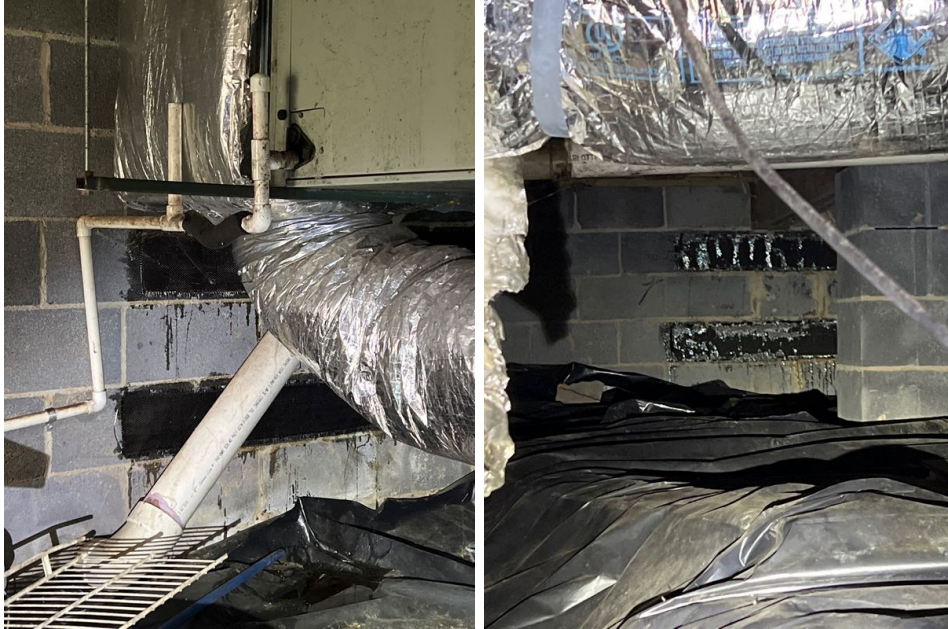
18.5.2 Foundation Walls - CSM

CRACKING - OUTSIDE OF NORMAL TOLERANCES

Contact the seller for more info
